Comprehensive Building Conditions Assessment Report

EFI File No.: 014.04649
December 4, 2022

Westborough Country Club
121 Main Street
Westborough, Massachusetts

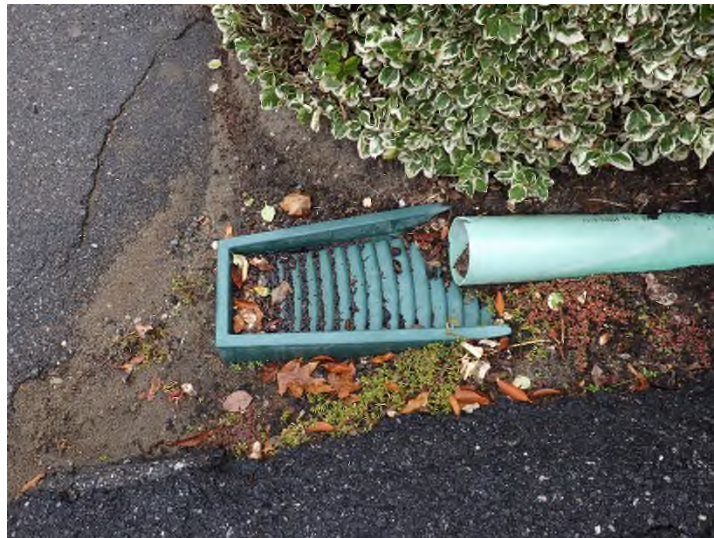
Since the building consists of an original two-story portion and multiple one-story additions and infills, the roof drainage was cobbled together when each addition was added. There are no gutters or downspouts to collect runoff from the second floor – it discharges directly onto the one-story roof area. There are some areas of the one-story wrap around additions where gutters and downspouts are provided. Portions of the Pro Shop have gutters and downspouts – some areas do not. The roof area that drains onto the rear deck does not have any gutters or downspouts. On the front side of the building one of the gutter downspouts was directed into a splash block (diverter) which was pointed in the wrong direction (back toward the building).

Photograph 3: Downspout Splash Guard

All roofs should have gutters and downspouts, with the downspouts collecting and discharging the runoff away from the building foundations.

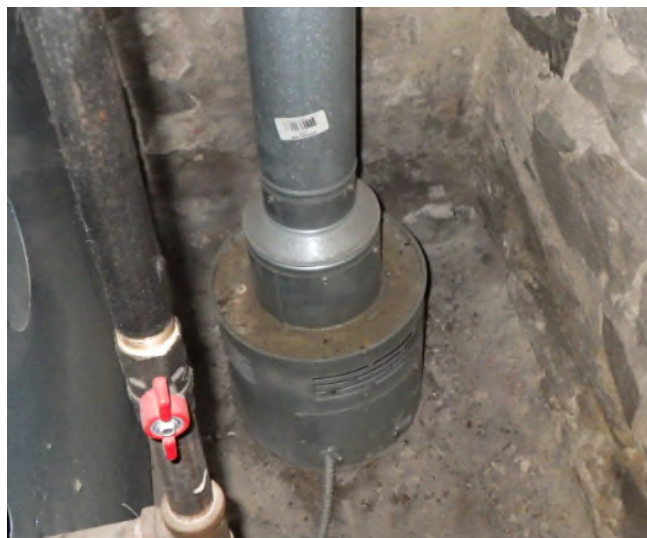
Figure 3: Combustion air supply fan,

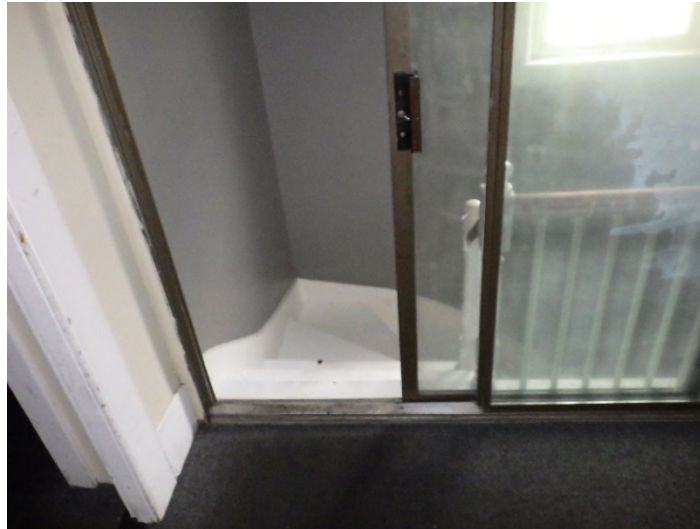
Based on information provided to EFI from the Town of Westborough, the second floor has been occupied since the building was purchased by the town and the Town believes that the building, therefore, did not

require upgraded egress. As noted above, however, that is an incorrect interpretation of the applicable codes and places the building's occupants at an unnecessary risk.

Photograph 9: Second Floor Rear Egress Sliding Glass Door

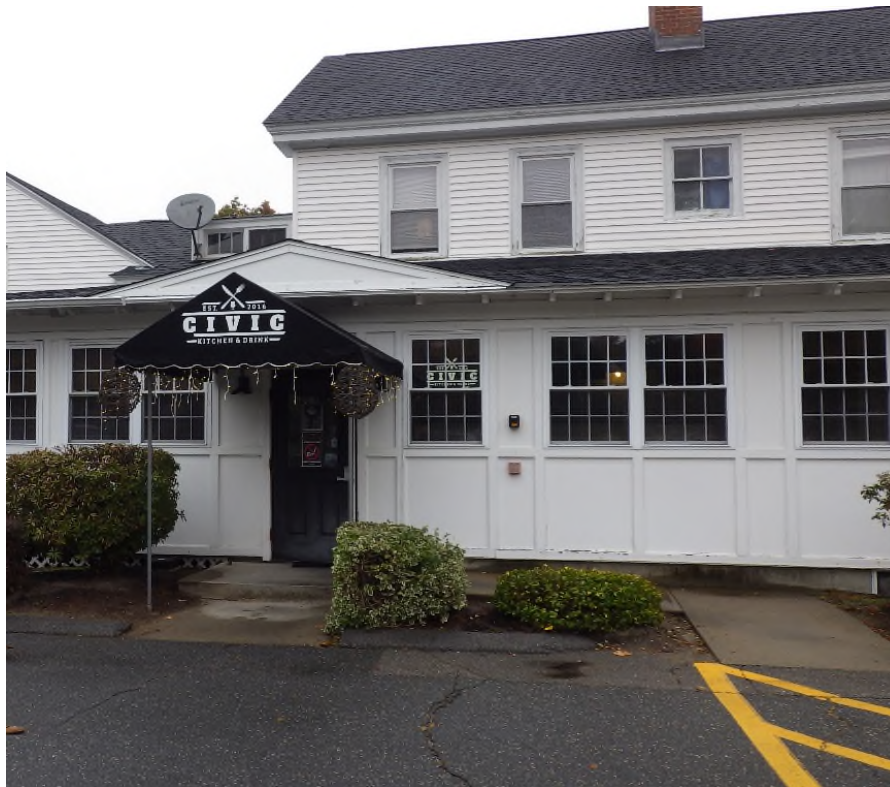
There is a ramp located along the west side providing access to the front entrance foyer. There is no railing. There is a single step up from the parking lot to the front entrance, but the step is not delineated with a different color to identify the change in elevation. Inside, there is a switch back ramp providing access to the maître d' station. See Pictures #47 and 48. There is an accessible exit to the rear deck from the bar area.

Photograph 17: Exterior Ramp & Stair at Restaurant Entrance

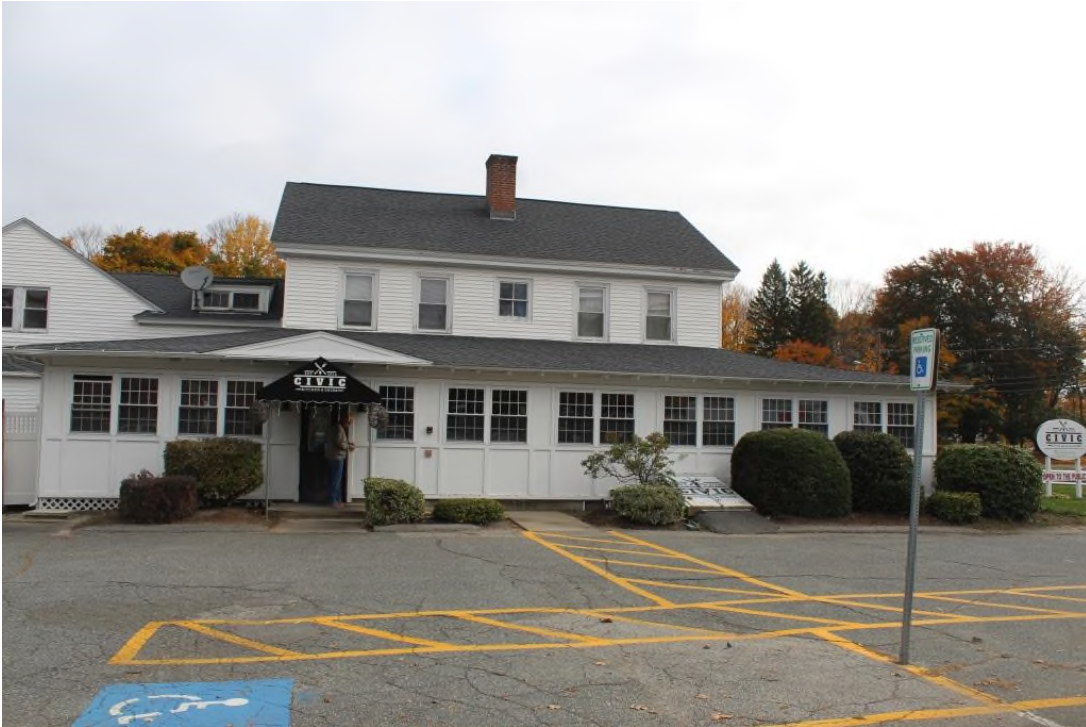
Photo No. 1: Front (west) face of building. Main entrance to restaurant at canopy, HC ramp on right.

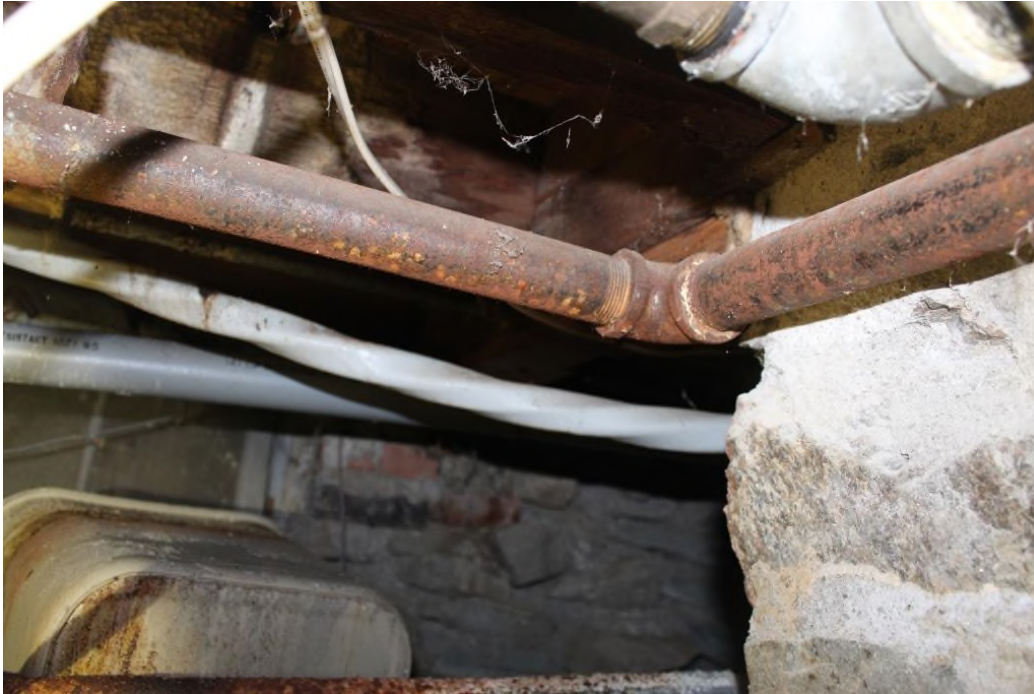
- There were numerous crawl spaces that were inaccessible. In the crawl spaces that were visible through small openings in the walls, hand-hewn timber beams were observed that were supporting mortise and tenon wood floor framing.

- Water damage and minor rot was observed to some first-floor framing in some areas of the crawl spaces.
- There were numerous interior brick bearing walls, all of which require repointing.

Photo No. 15: View inside one of the crawl spaces. Partial stone foundation wall on right.

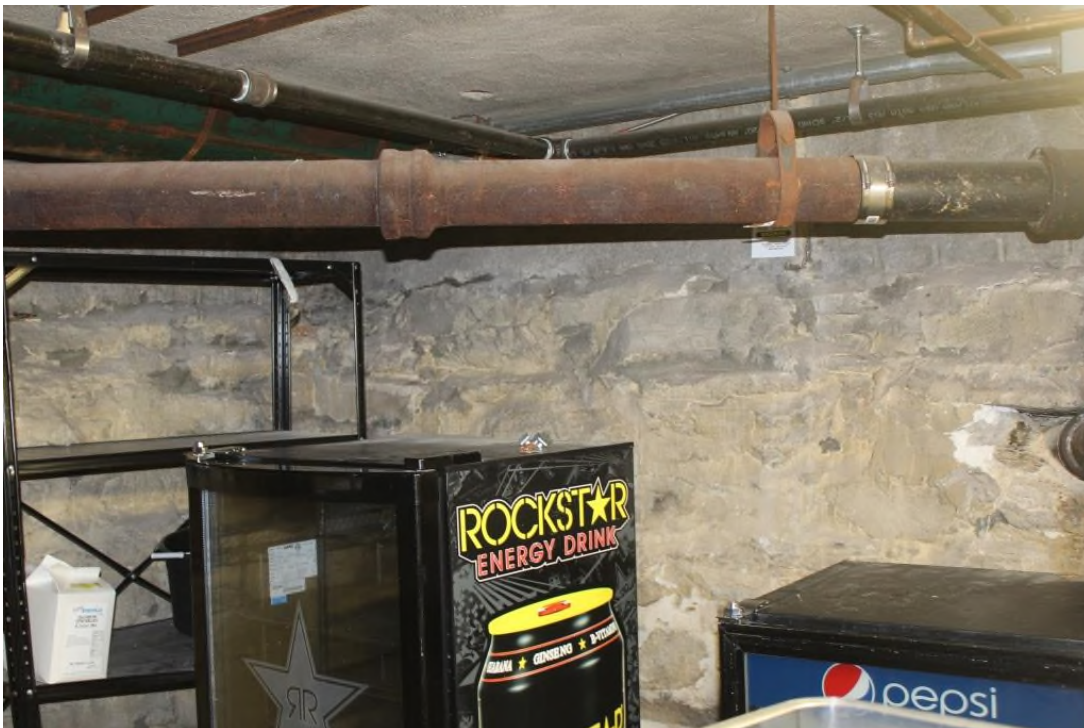
- The basement floor consists of a concrete slab on grade,
- The stone walls consist of hand-set stones topped with quarried stone block.
- Some water staining and minor fungal growth was noted on several stone foundation walls.
- The foundations appear to be in good condition, but are likely not waterproof, given the age of the building.
- EFI did not observe any visual structural defects to the foundation.
- See Pictures 12 through 21.

Photo No. 16: View of typical stone foundation wall.

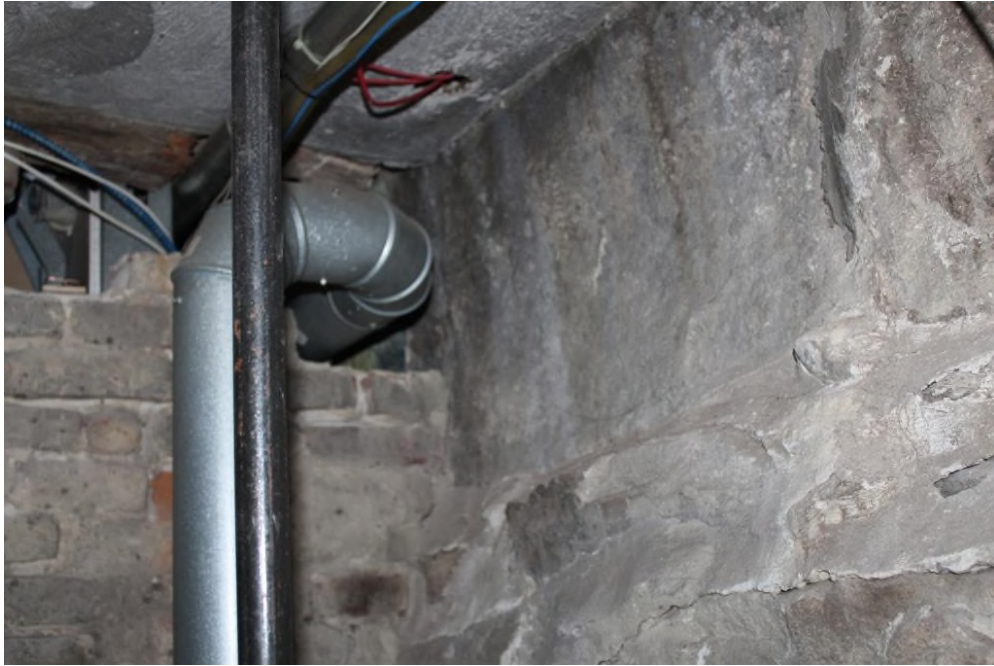
Photo No. 17: Intersection of exterior stone foundation wall (right) and interior brick bearing wall (left). Crawl space beyond.

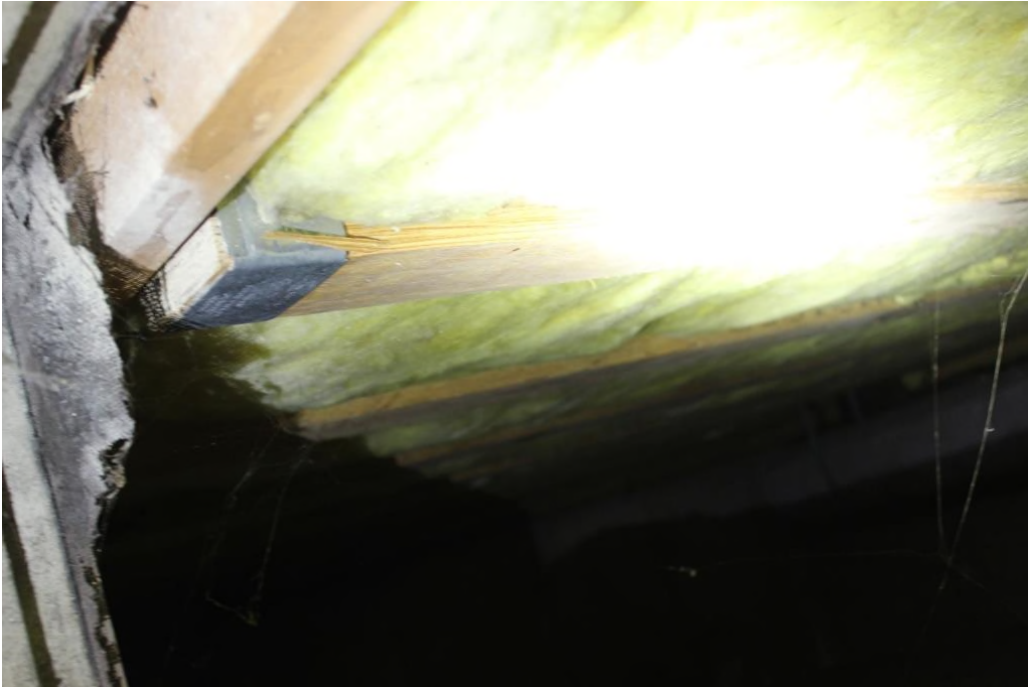
Photo No. 19: Newer wood framing below west side addition adjacent top bulkhead doors.

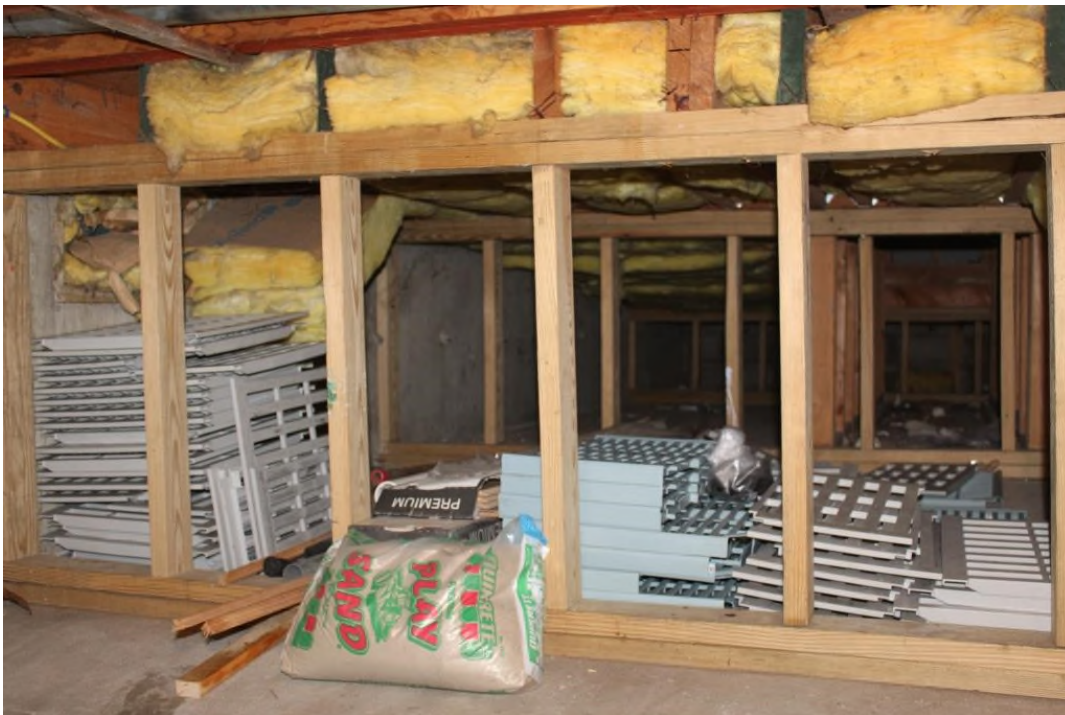
Photo No. 20: Interior bearing wall beneath west side addition.

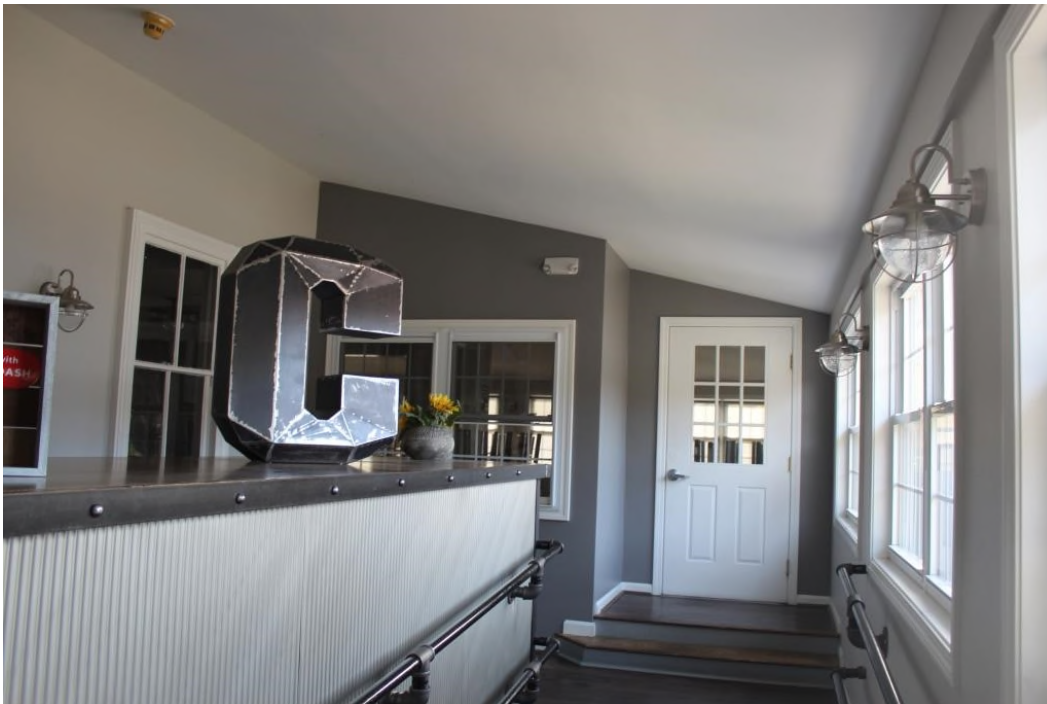
Photo No. 22: First floor interior condition at front entrance. HC ramp leads up to steps, turns 180°, and extends to interior door entrance.

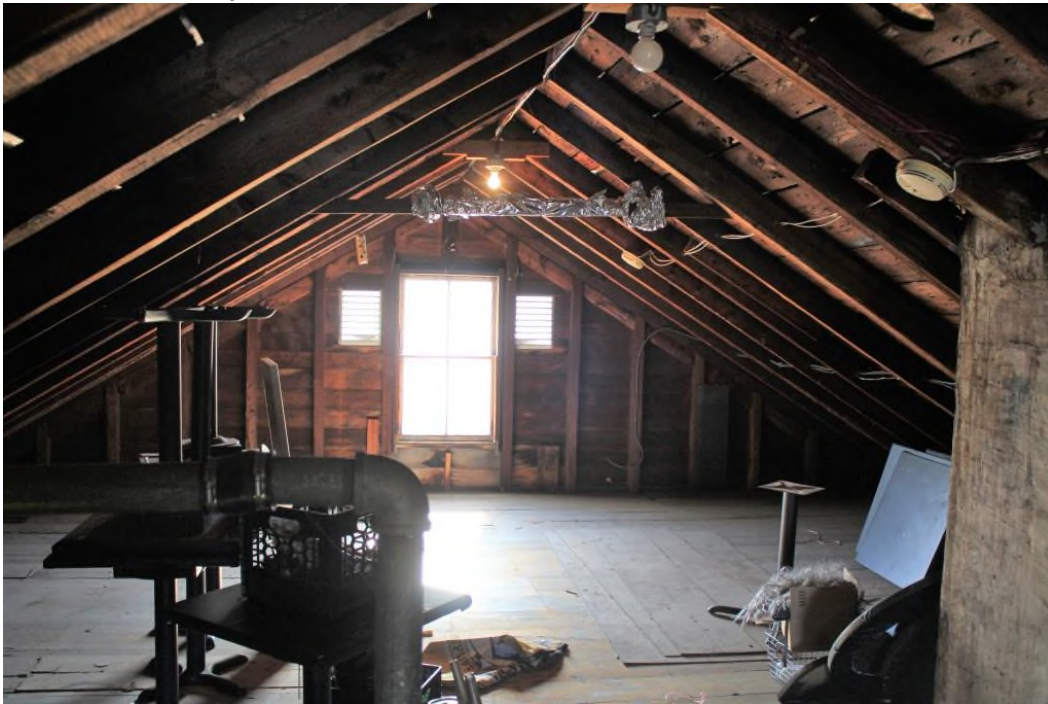
- The attic floor was covered with a combination of different sized wood planks.
- The floor framing was visible in a small area and the joists span from north to south, perpendicular to the roof framing.
- The exterior walls were balloon framed.
- Unfaced batt insulation was present in the attic floor
- See Pictures #34 and 41.

Photo No. 34: Typical attic framing.

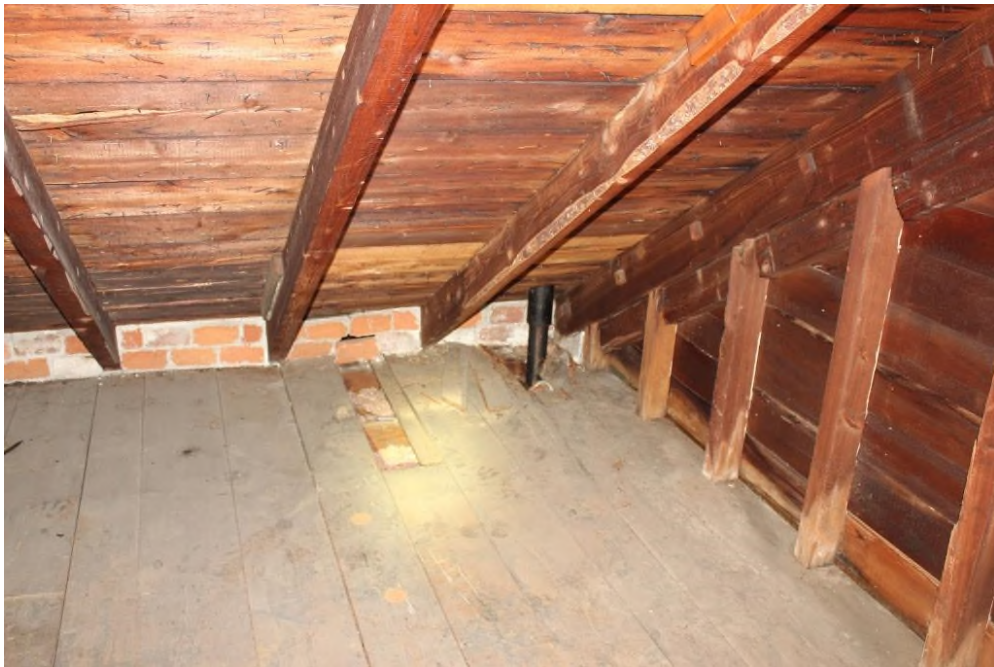
Photo No. 40: Roof rafter support condition at eaves. Note infill brick between rafters.

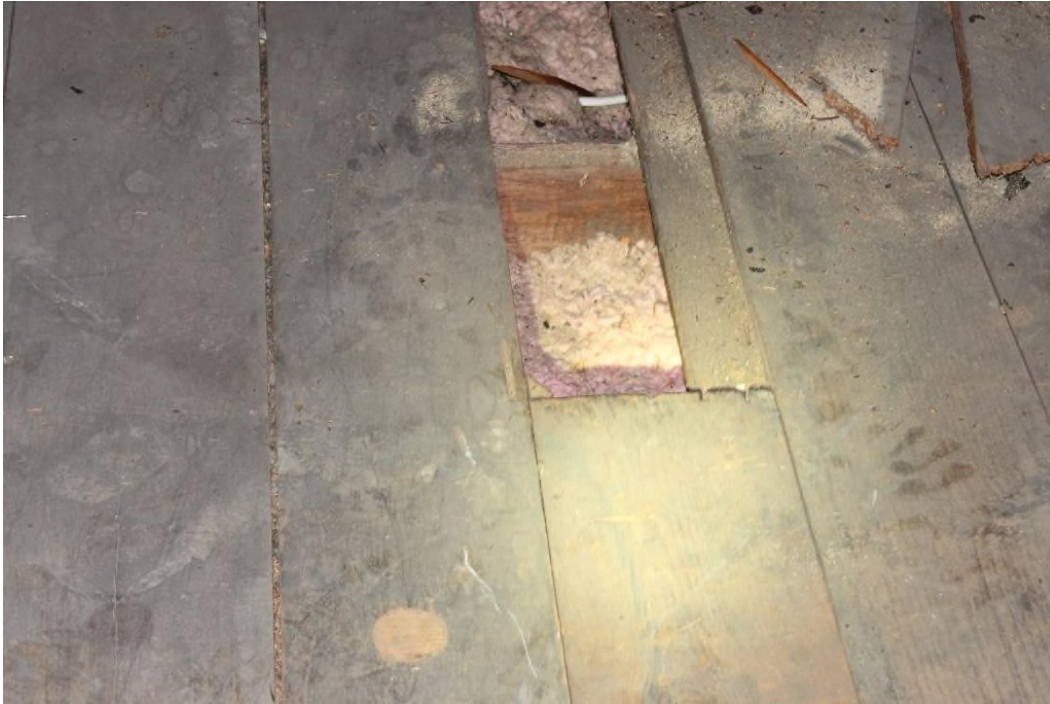
Photo No. 41: Attic floor framing exposed. Extended perpendicular to roof framing.

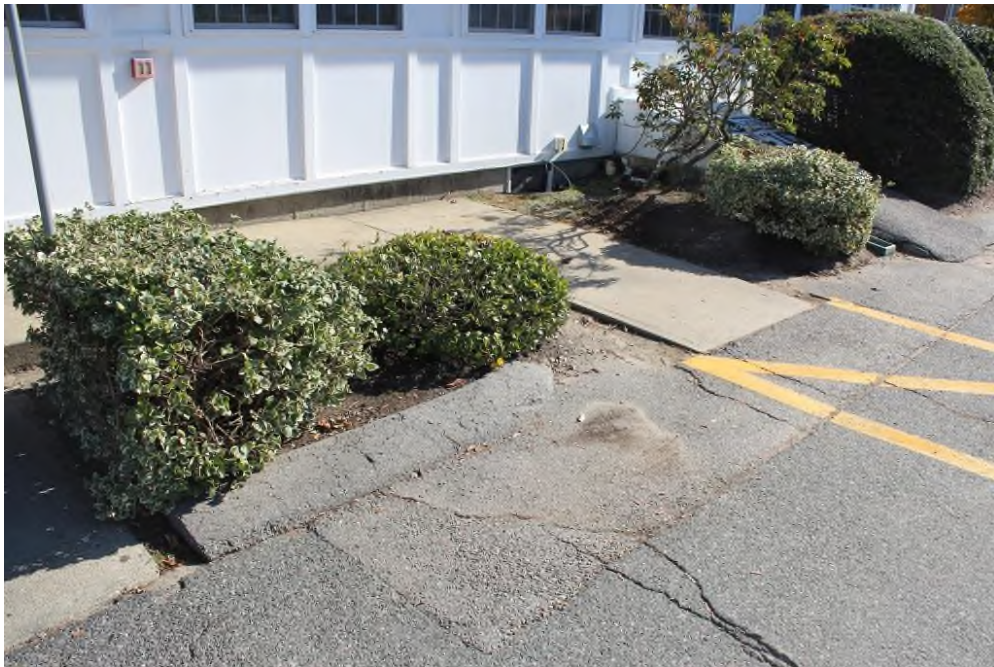
Photo No. 48: HC ramp to restaurant entrance.

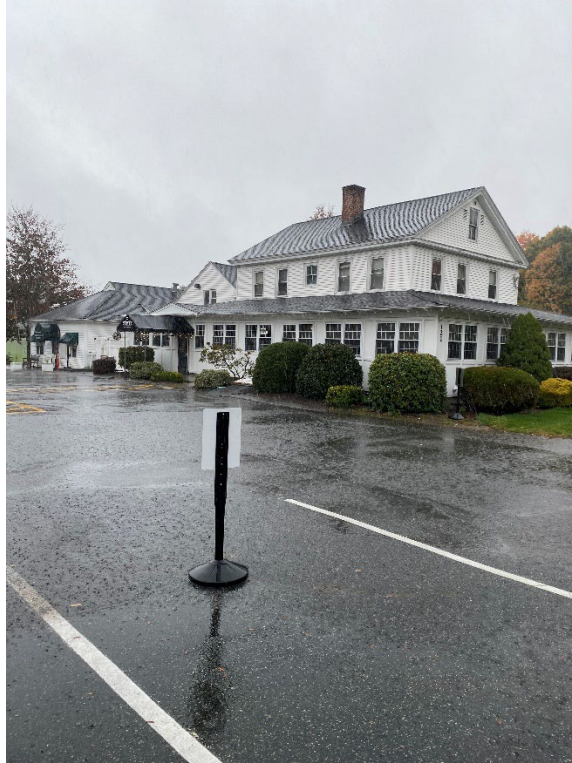
Westborough Country Club – Original Building (right side of photograph).
1995 Addition (left side of photograph)

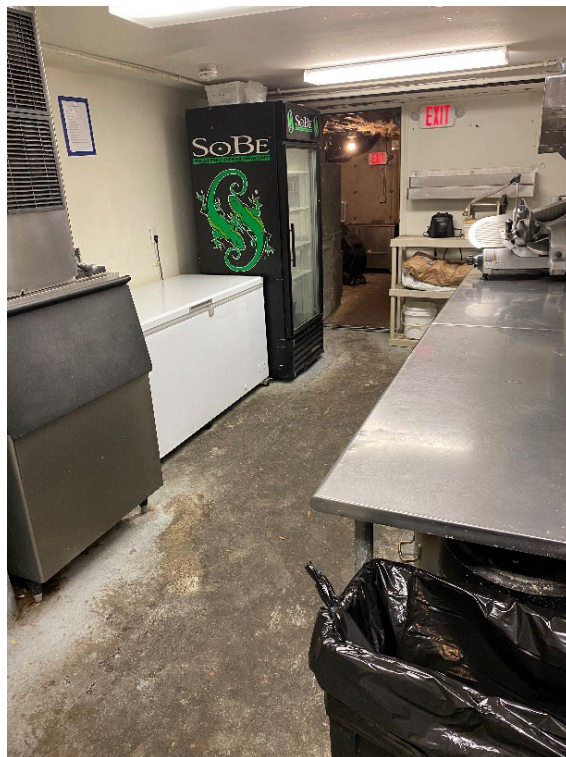
Original Building – Basement Food Prep Area

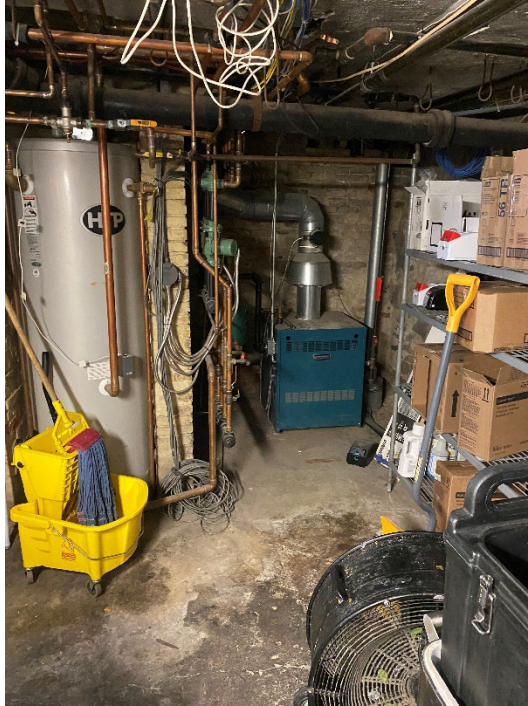
Original Building – Basement Boiler Room

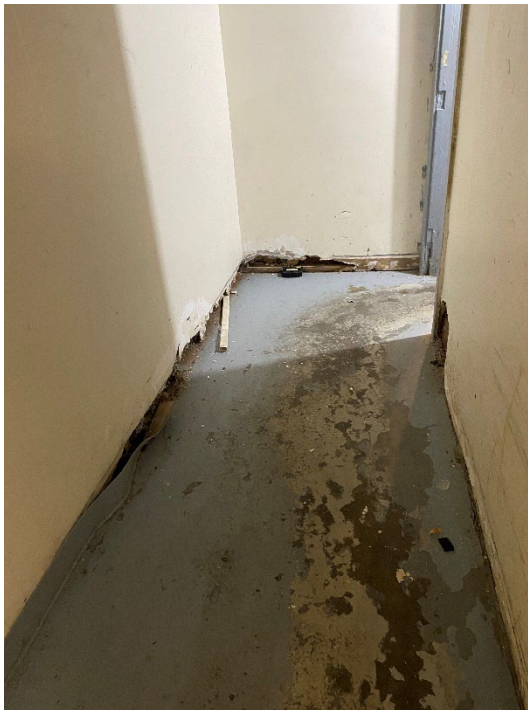
Original Building – Basement Hall to Food Prep Area

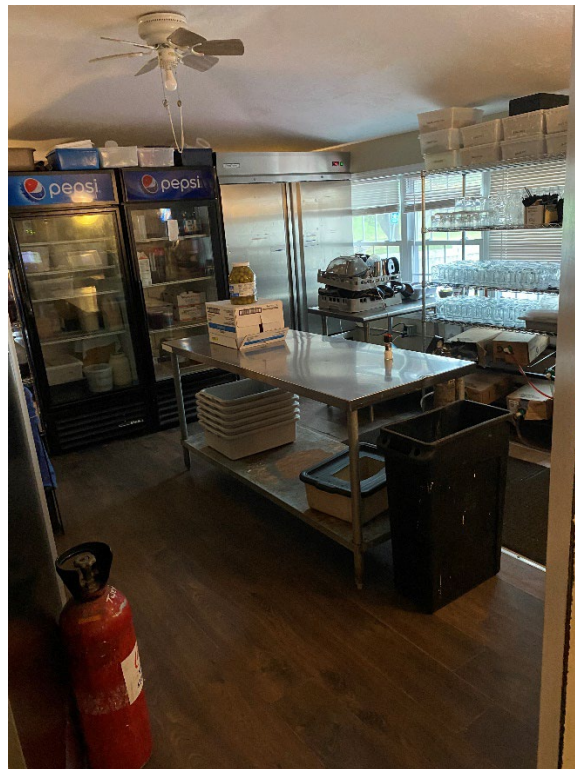
Original Building – 1st Floor Kitchen Pantry

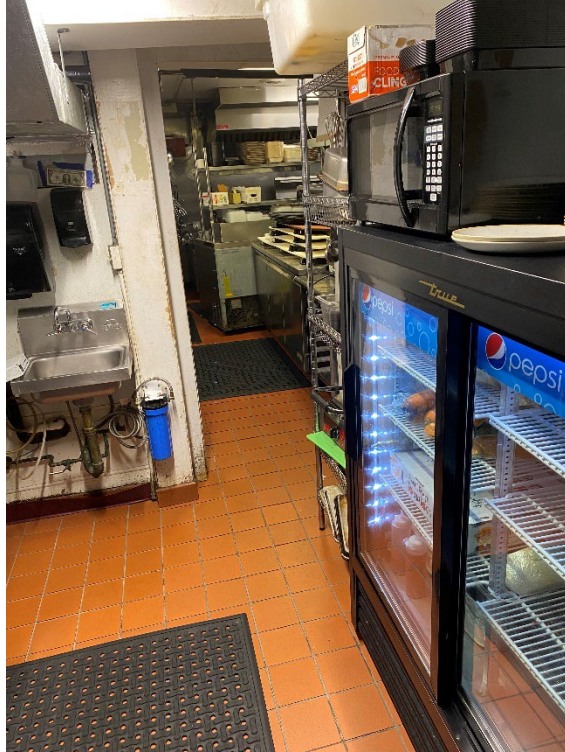
Original Building – 1st Floor Kitchen

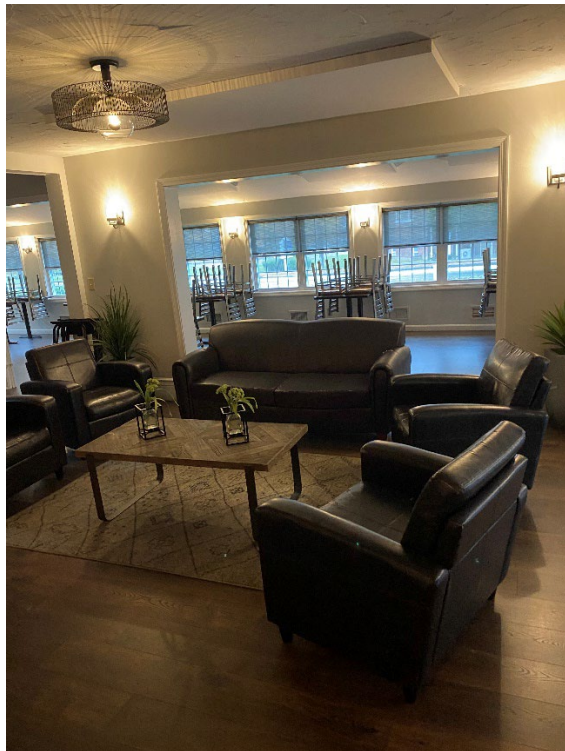
Original Building – 1st Floor Dining Area

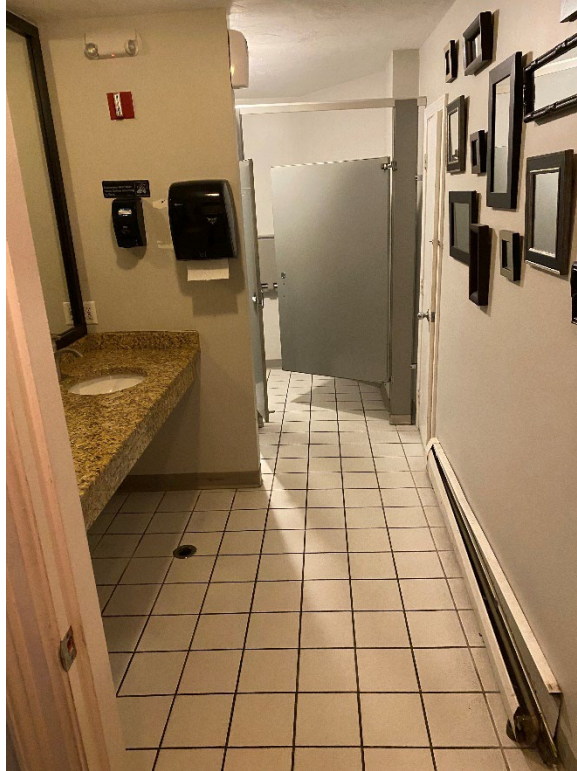
Original Building – 1st Floor Women's Room

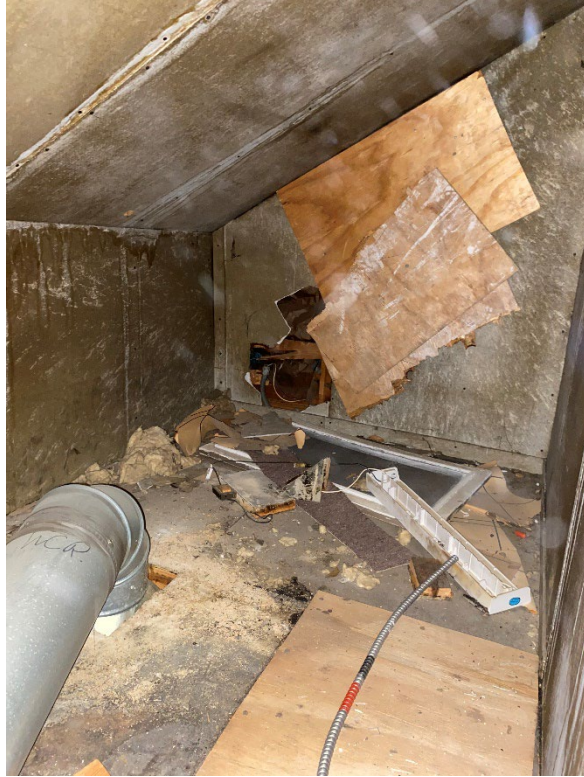
Original Building – 2nd Floor North End Attic Space

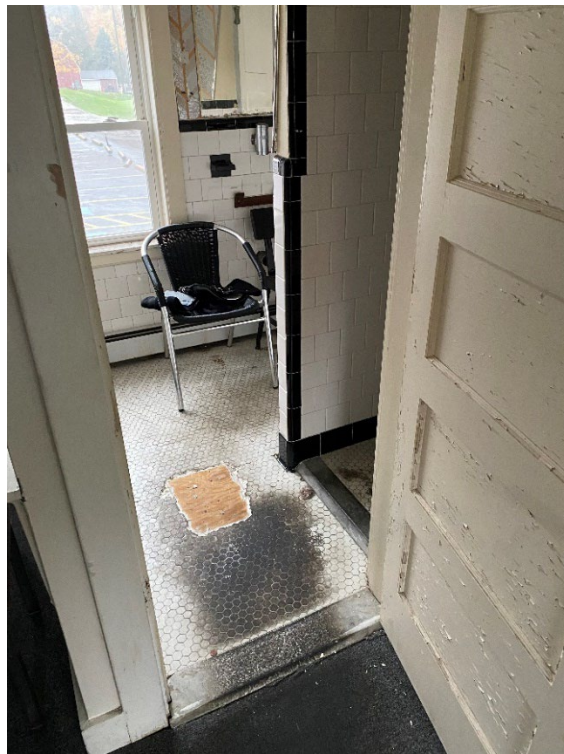
Original Building - 2nd Floor North End Restroom

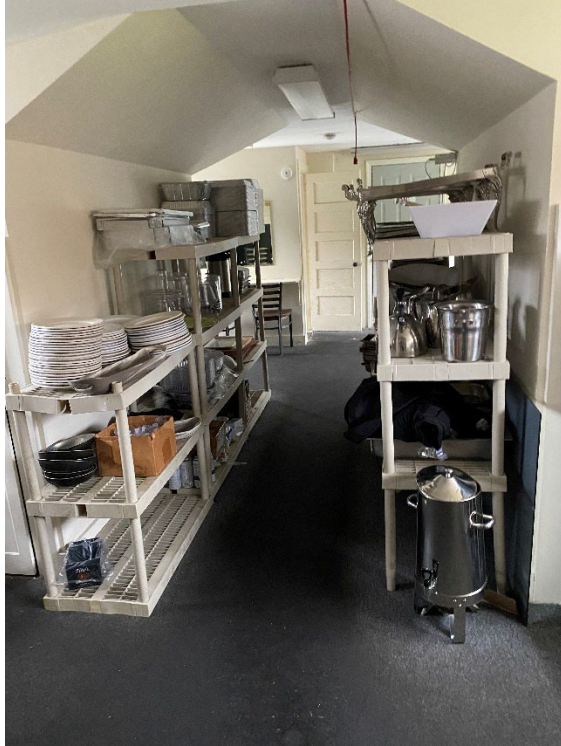
Original Building - 2nd Floor South End Storage Area

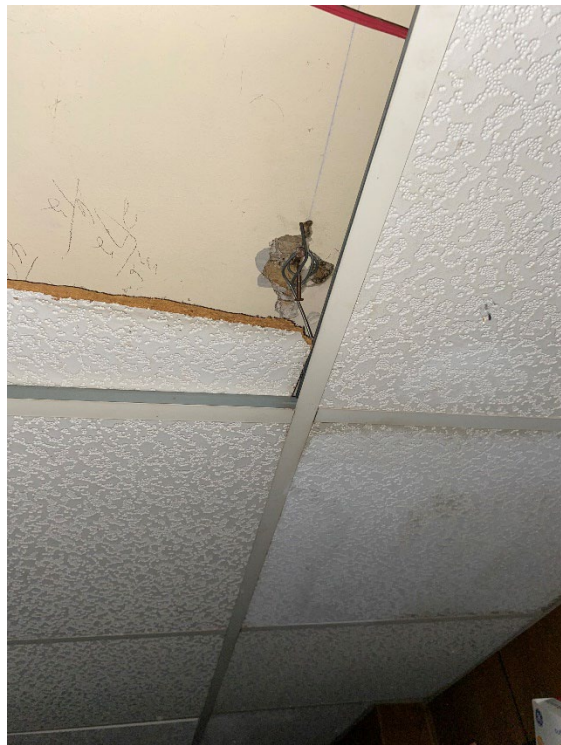
Original Building - 2nd Floor Storage Room

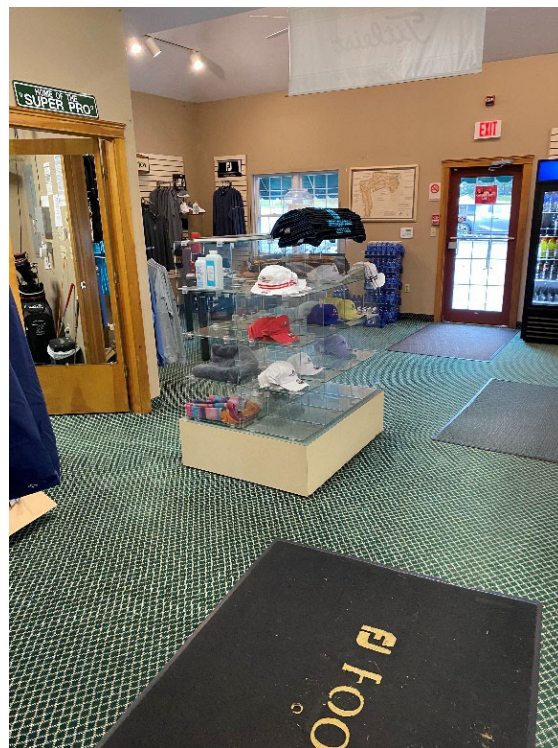
1995 Addition – Pro Shop Retail Area

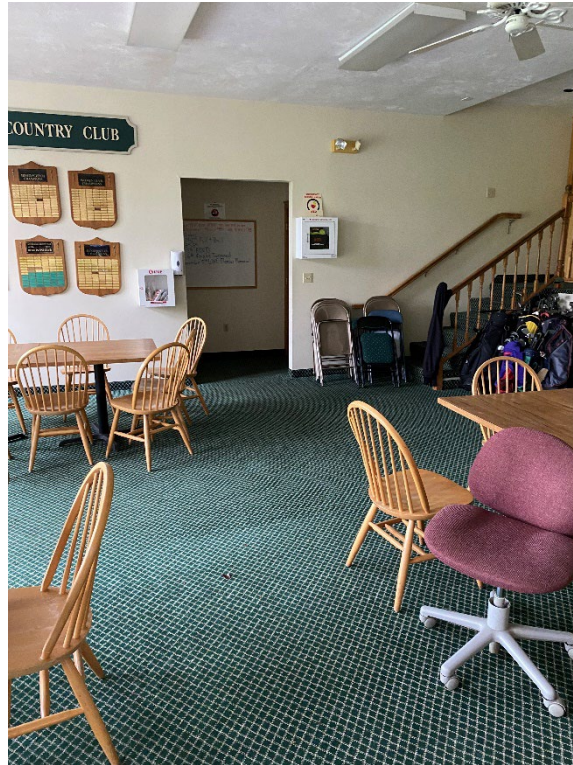
1995 Addition – Club House Area

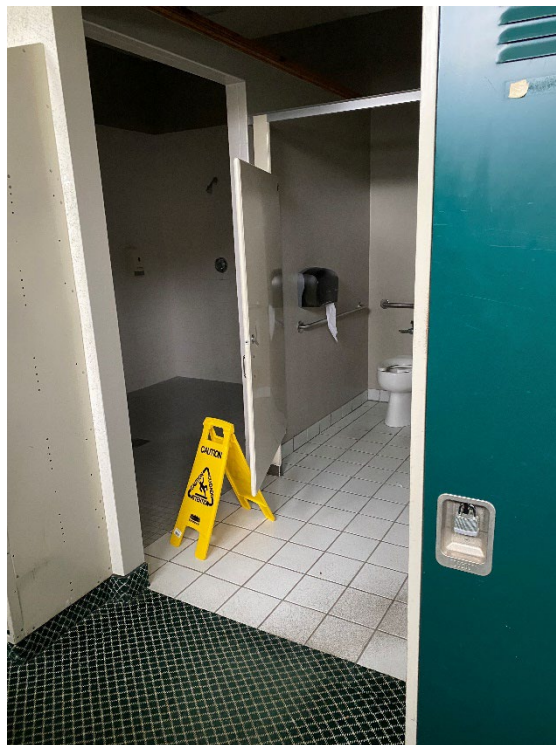
1995 Addition – Men's Locker Room.

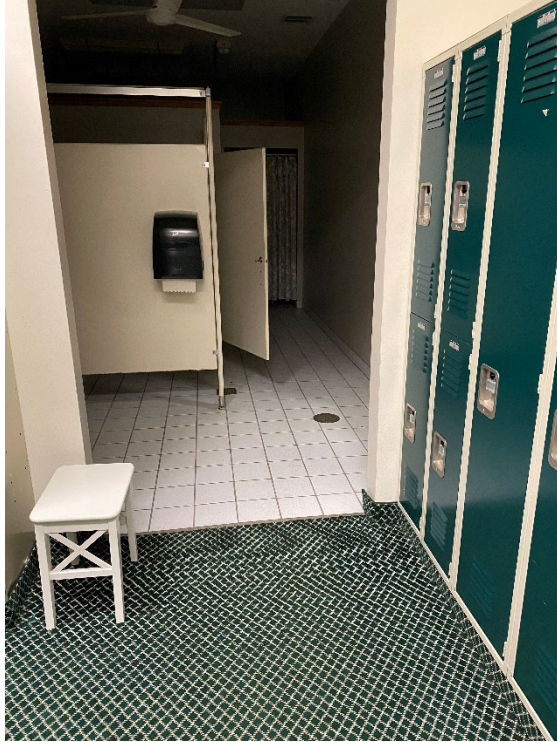
1995 Addition – Women's Locker Room
